# Monitoring of remediation works to arrest stream degradation in an agriculture-dominated catchment

Andrea L. Wilson, Robyn J. Watts, Ken J. Page and Remy Dehaan

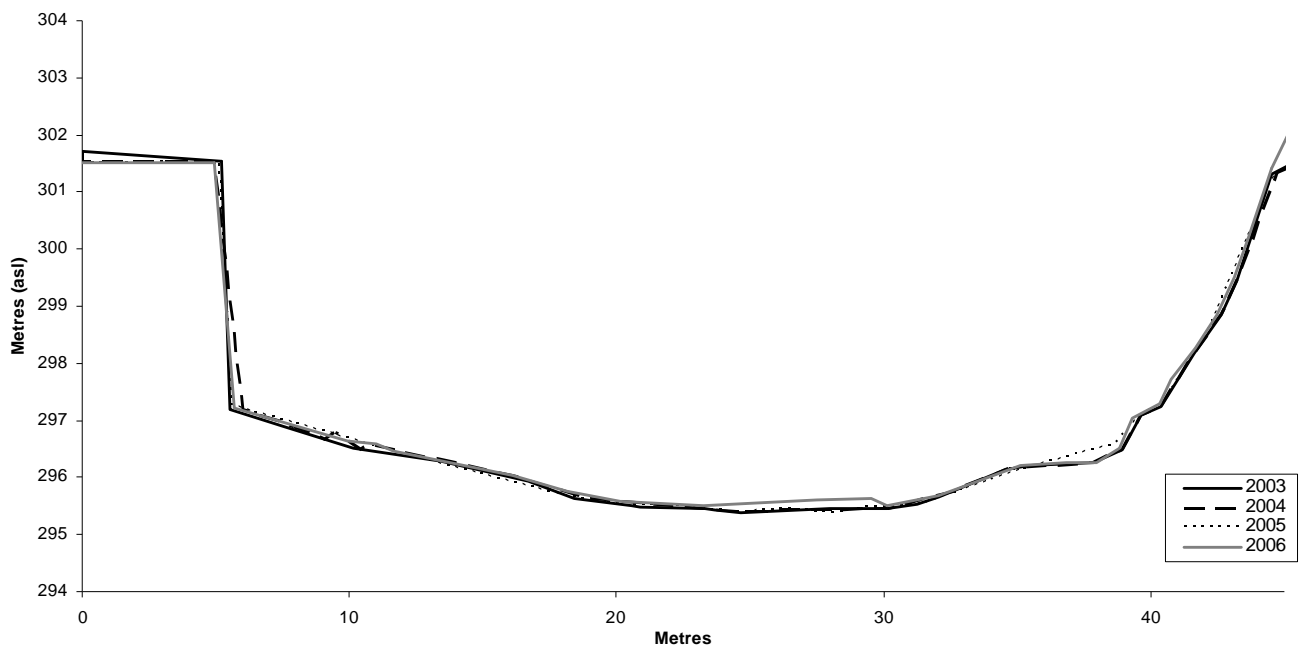
Channel cross sections surveyed at the three reaches of Umbango Creek showed that relatively little change to channel morphology occurred at the log groyne reach during the study period (e.g. Figure 5). This channel stability reflects the generally low flow conditions throughout 2003 and 2004 when the Creek experienced low discharge conditions with flow velocities below those required to entrain cobbles. Minor river freshes, which occurred in August 2003 and September 2004 following widespread rainfall in the catchment had very little impact. Changes to channel morphology as a result of a higher flood pulse in 2005 were evident only at the levee bank reach where substantial bank erosion and thalweg deepening occurred (Figure 6).

**Figure 5. Channel cross sections at log groyne reach in Umbango Creek surveyed in 2003, 2004, 2005 and 2006.**

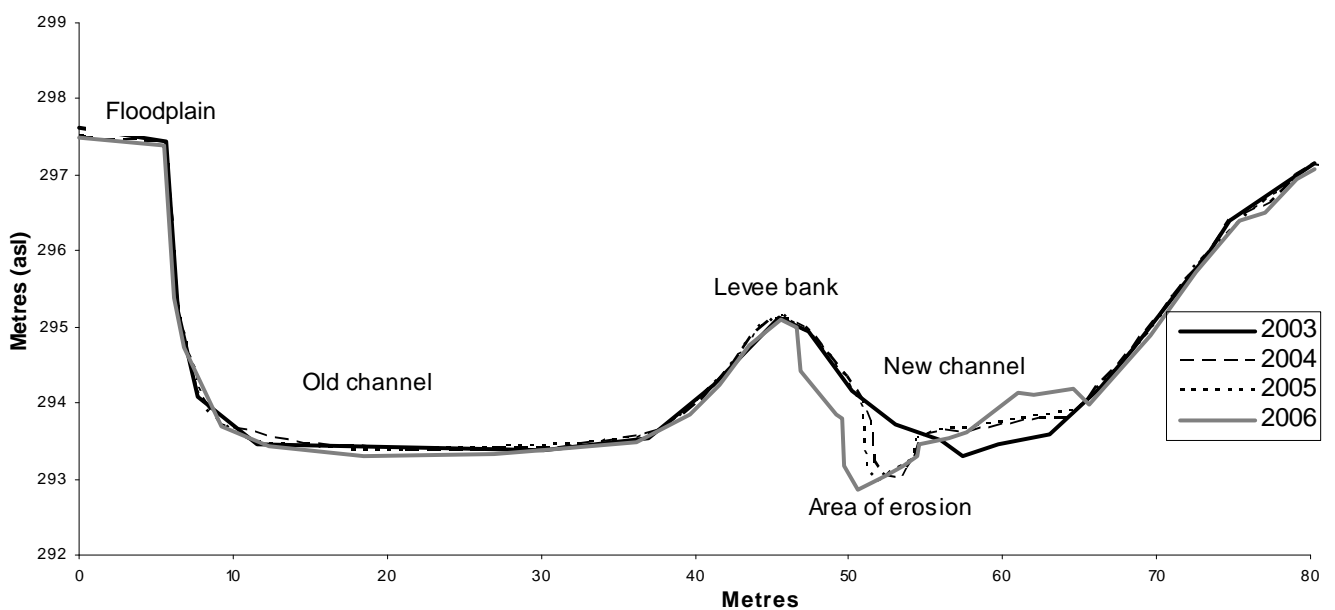
**Figure 6. Channel cross sections at levee bank reach in Umbango Creek surveyed in 2003, 2004, 2005 and 2006.**

It is apparent from Figure 5 that erosion of the levee bank occurred at the bend axis after the high flows in late 2005. Bend shortening at this reach has increased local channel slope and potential bed shear. The vulnerability of the constructed levee bank to future bend erosion presents a challenge to the on-going success of remediation work in this reach and therefore requires periodic monitoring. However, the lack of a significant breach of the levee bank earthworks during a substantial discharge event suggests an increase in bank strength resulting from enhanced vegetation cover (Hickin, 1984). Additionally, the presence of trees, shrubs, ground cover and in-stream vegetation is likely to have enhanced channel roughness and therefore reduced flow velocity in the study reaches.
