Update #2 on water quality monitoring in the Edward-Wakool system

Robyn Watts and Julia Howitt, Institute for Land, Water and Society
Charles Sturt University, 16/3/2016

Sites monitored 14th to 15th March 2016

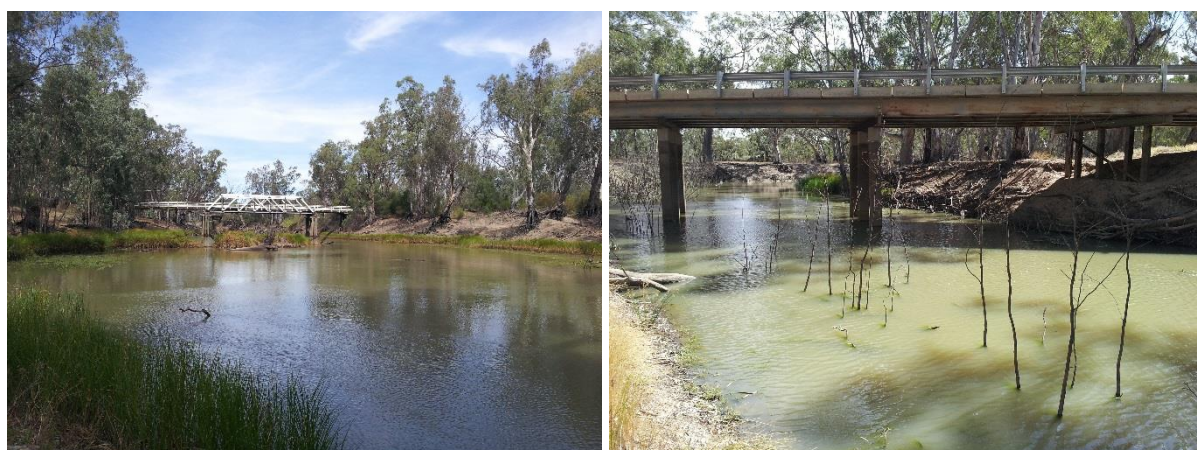
The blue-green algal bloom was evident at 12 of the 14 monitoring sites. The bloom was not yet evident at Gee Gee Bridge on the Wakool River (Figure 2a) or Nancurrie Road Bridge on the Niemur River (Figures 2b).

Figure 2. a) No blue green algae was evident at Gee Gee bridge on the Wakool River 14/3/16. b) No blue green algae evident at Nancurrie Road bridge on the Niemur River 14/3/16 (Photos R. Watts)

- The turbidity of the water was considerably lower at the sites where there was no algal bloom evident. It was 42.7 NTU in the Wakool River at Gee Gee bridge and 74.4 NTU in the Niemur River at Nancurrie Bridge.

- The algal bloom has not yet reached Gee Gee Bridge on the Wakool River or Nancurrie Rd bridge in the Niemur River. So the areas of the Wakool River and Niemur River downstream of these two sites presumably have good water quality and are currently providing refuge for biota from the bloom. So delivery of additional flow from Stevens Weir could potentially push the bloom downstream at a faster rate.

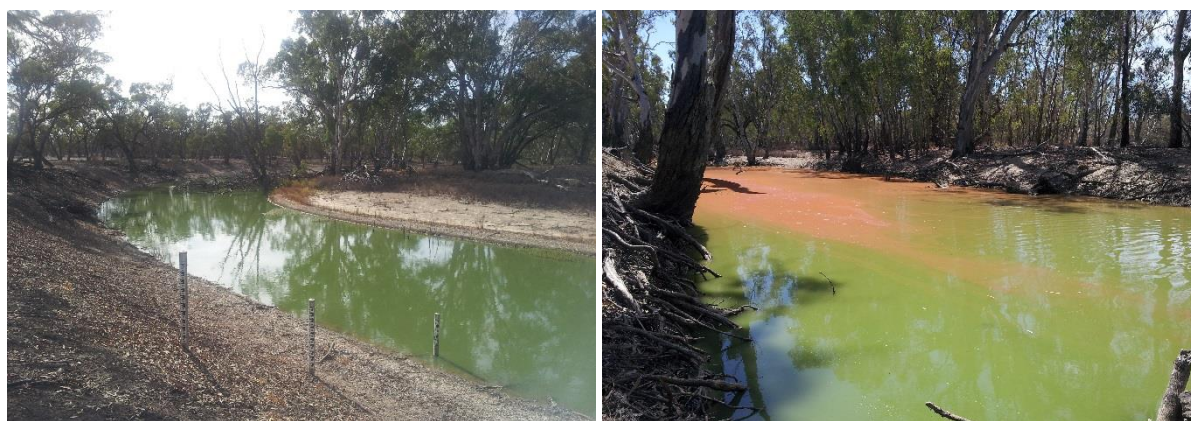
Similar to observations on 7/3/16, the algae appeared to be in lower concentration in the higher discharge faster flowing water in Yallakool Creek compared to other sites where the water was flowing slowly. No scum was present in Yallakool Creek (Figure 3a).

The bloom was particularly bad in the upper Wakool River, LTIM zone 2 site 6 (Widgee 1) where there was a large area of red coloured scum in the slower flowing pools (Figure 3b). A reddish coloured scum was also evident at mid Wakool River, LTIM zone 3 site 2 (Tralee) and LTIM zone 3 site 10 (Llanos Park)(Figure 4a).

Figure 3. a) No scum present at Yallakool Creek 'Windra Vale' 15/3/16 b) Red scum forming in slower flowing sections of the Wakool River zone 2 at 'Widgee' 14/3/16 (Photos: R. Watts)

- At sites where the water was flowing faster (e.g. Yallakool Creek and the Mulwala Canal at Berrigan) there was no scum present and the water quality appeared to be slightly better than at sites where the water was flowing very slowly or was still. This could be due to the algae not being able to maintain their position at the top of the water column. Also the turbulence of the faster flowing water may prevent the establishment of a very thin warm layer of surface water – the cyanobacteria can reproduce faster in warmer water. However, given that the source water in Stevens and the canal is affected by the algal bloom, it is difficult to predict whether delivery of water would significantly improve water quality downstream.

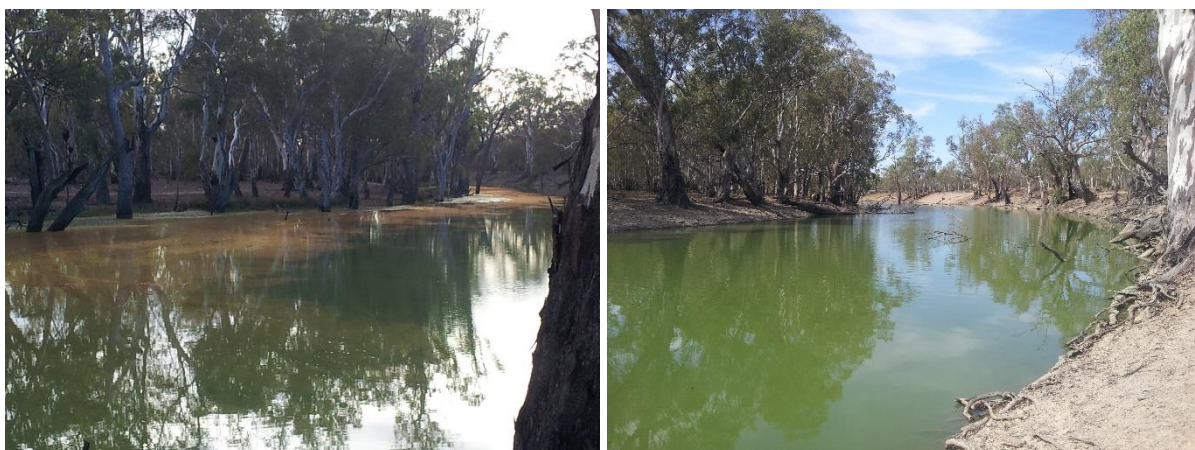
The algal bloom was a thick green colour in Colligen Creek (Figure 4b) and Wakool River zone 4 at 'Noorong'. The bloom was evident in Stevens Weir on the Edward River, but no scum was present (Figure 5a). The Mulwala canal at the Denilquin-Wakool Road (Figure 5b) was banked up against the regulator and was not flowing, however no scum was evident.

Figure 4. a) Red scum forming in slower flowing sections of the Wakool River zone 3 at Llanos Park. 15/3/16 b) no scum present at Colligen Creek 15/3/16 (Photos: R. Watts)

- The red scum could be an indication that the algal bloom is starting to break down. However, it is unclear if this is the case because there is very little available information on how *Aphanizomenon* blooms develop and decay.

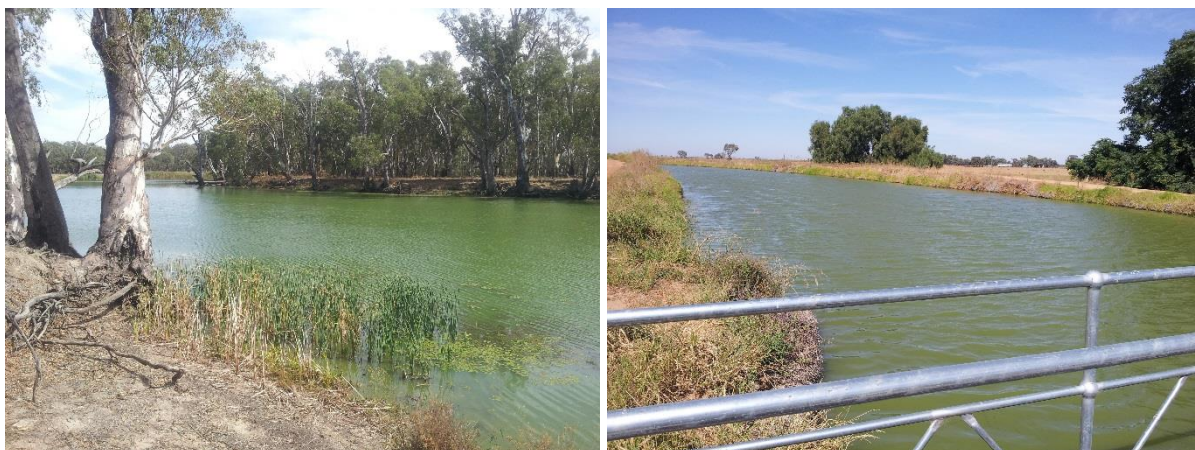
Figure 5. The bloom was evident in a) Stevens Weir on the Edward River 15/3/16 and b) Mulwala Canal at the Wakool Road 14/3/16, but no scum was present at either of these sites. (Photos: R. Watts)

- The water in the canal at the Deniliquin-Wakool Road crossing was banked up against the gate and was not flowing. I also took spot measures in the canal near Berrigan where it was flowing strongly. The turbidity was considerably lower in the canal at Berrigan.

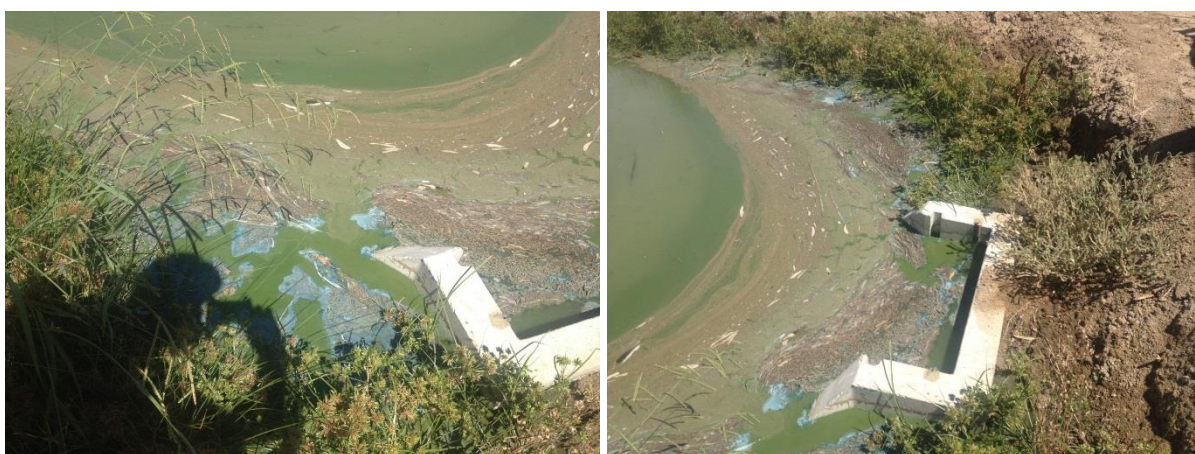
Observations from John Lolicato, Wakool landholder, was that when his irrigation channel was flowing at 10 ML/day there was no scum, but the next day after he had stopped pumping a red scum appeared in the standing water and parts of the scum were iridescent blue (Figure 6).

Figure 6. Iridescent blue algal scum forming in irrigation channel after water was turned off and water was standing for one day (Photo: John Lolicato)

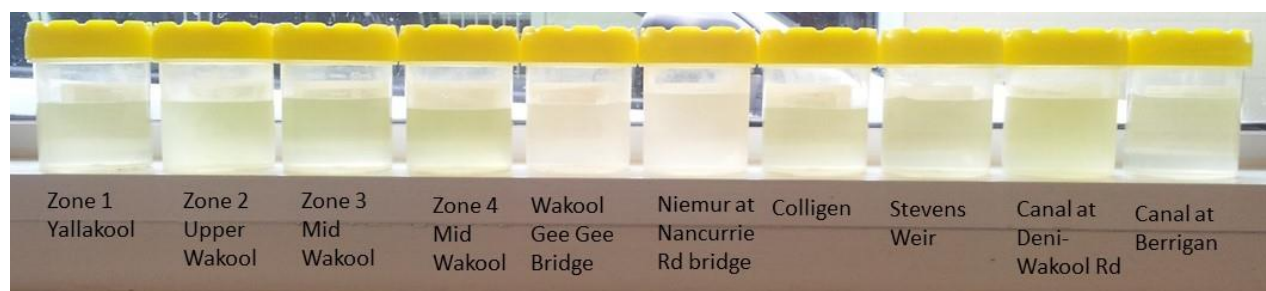
Visual assessment of water confirms the observations earlier in this report that the algae was not evident in the Wakool River at Gee Gee bridge and the Niemur River at Nancurrie Road bridge (Figure 7). The Mulwala canal at Berrigan that was flowing strongly appeared to have less algae than the canal the Deniliquin-Wakool Rd crossing where it was not flowing (Figure 7).

Figure 7. Water samples from sites in the Edward-Wakool system collected on 14/3/16 and 15/3/16
